ENGINEERING STUDY OF SELECTED LOCATIONS EXPERIENCING HIGH ACCIDENT FREQUENCY UNDER SNOWY AND ICY ROADWAY CONDITIONS

PREPARED BY
PROJECT PLANNING SECTION
PLANNING AND RESEARCH BUREAU
ENGINEERING DIVISION
MONTANA DEPT. OF HIGHWAYS

MONTANA DEPT. OF COMMUNITY AFFAIRS
HIGHWAY TRAFFIC SAFETY DIVISION

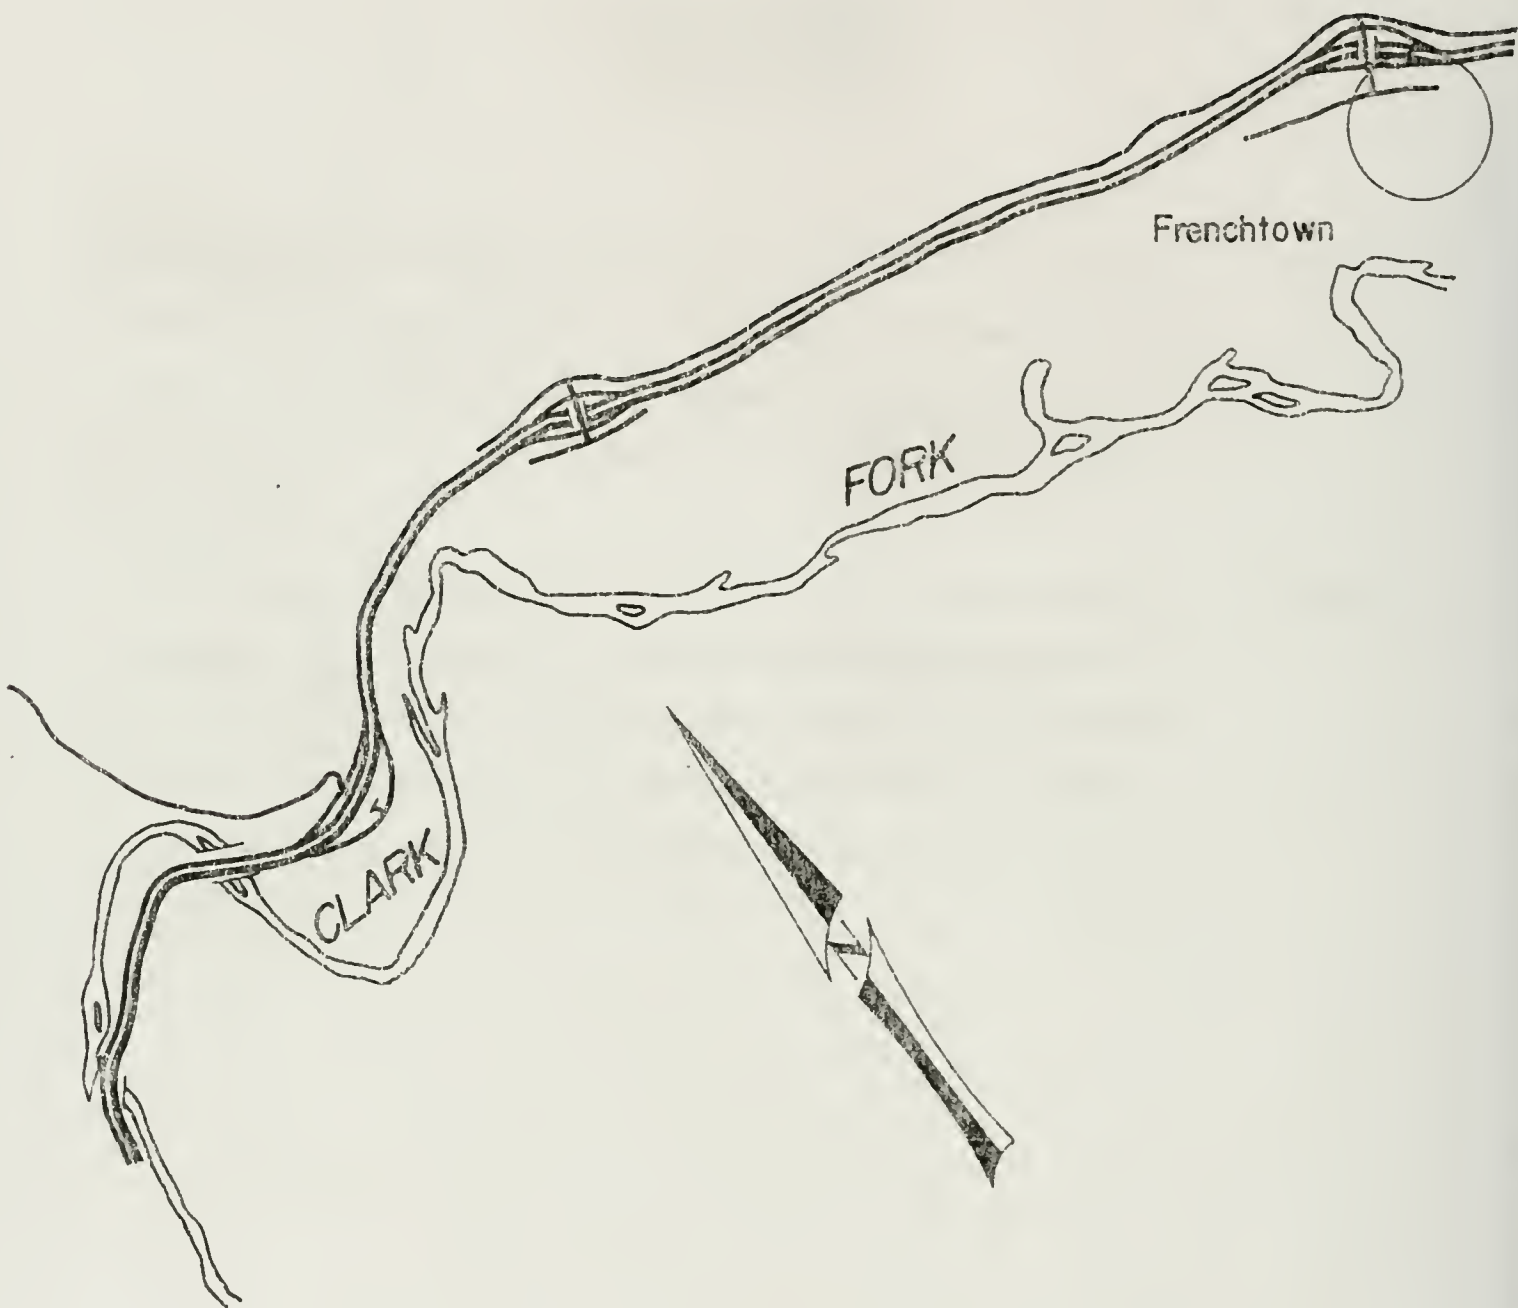
MILEPOST 80 - MILEPOST 90

General: The Study area is a 4-lane section with concrete driving lanes and asphalt shoulders. At Milepost 80 - 82 a recently completed add two lanes project was opened to the driving public in 1979. The section traverses fairly level terrain.

Comment: Accident experience for this section was misplaced, therefore is not reflected on the adjoining map. A clustering of accidents has occurred at approximately Milepost 82 on a verticle curve. A clustering of accidents has also occurred on a curve section at Milepost 88.5⁺ and at the Frenchtown Interchange at Milepost 89.5⁺.

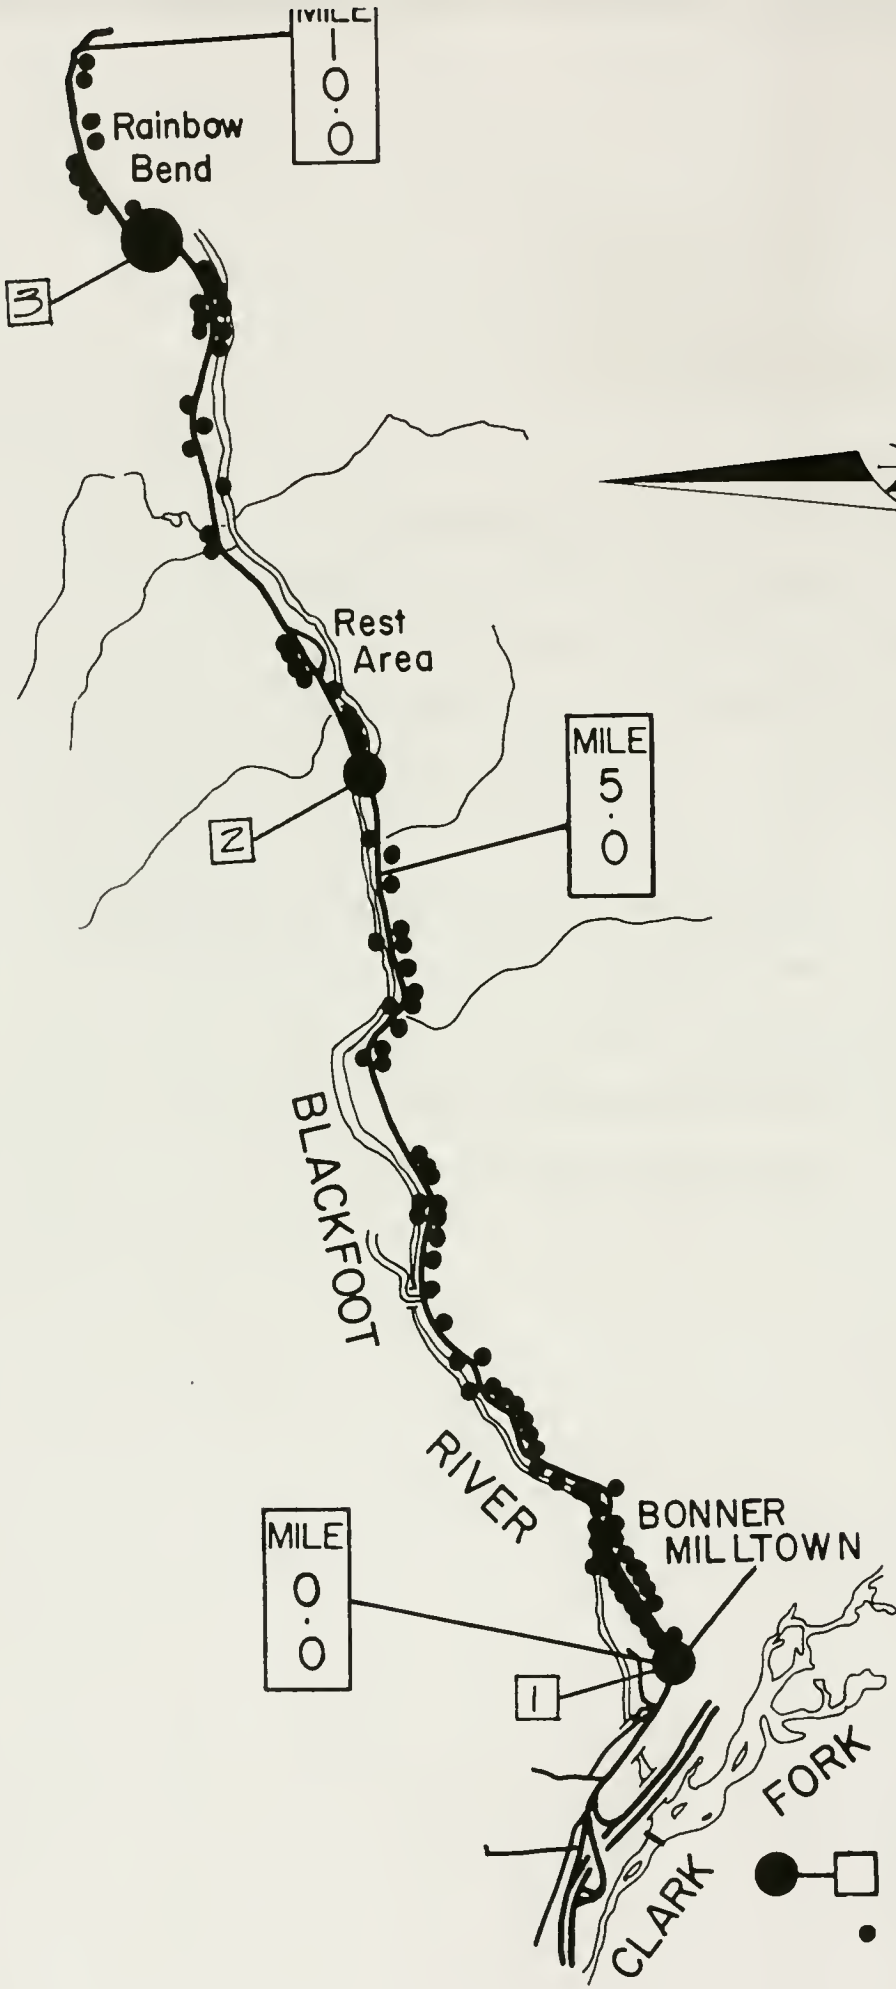
MILEPOST 0 - MILEPOST 10
 ACCIDENT CLUSTER SITES
 ● INDIVIDUAL ACCIDENTS
 Scale: 1 inch = 1 mile

General: The section begins near the Interstate 90 Bonner Interchange at Bonner and traverses the Blackfoot River East. Construction periods vary through the section. The beginning portion was constructed or altered to provide interstate connections. The easterly portion is basically old road with numerous curves.

Comment: Accident history is concentrated at the beginning of the route and at a curve section commonly known as Rainbow Bend. A safety project is in the planning stage for this area. Also special side of the road delineation was placed in this area to provide positive guidance around the sharp curves.

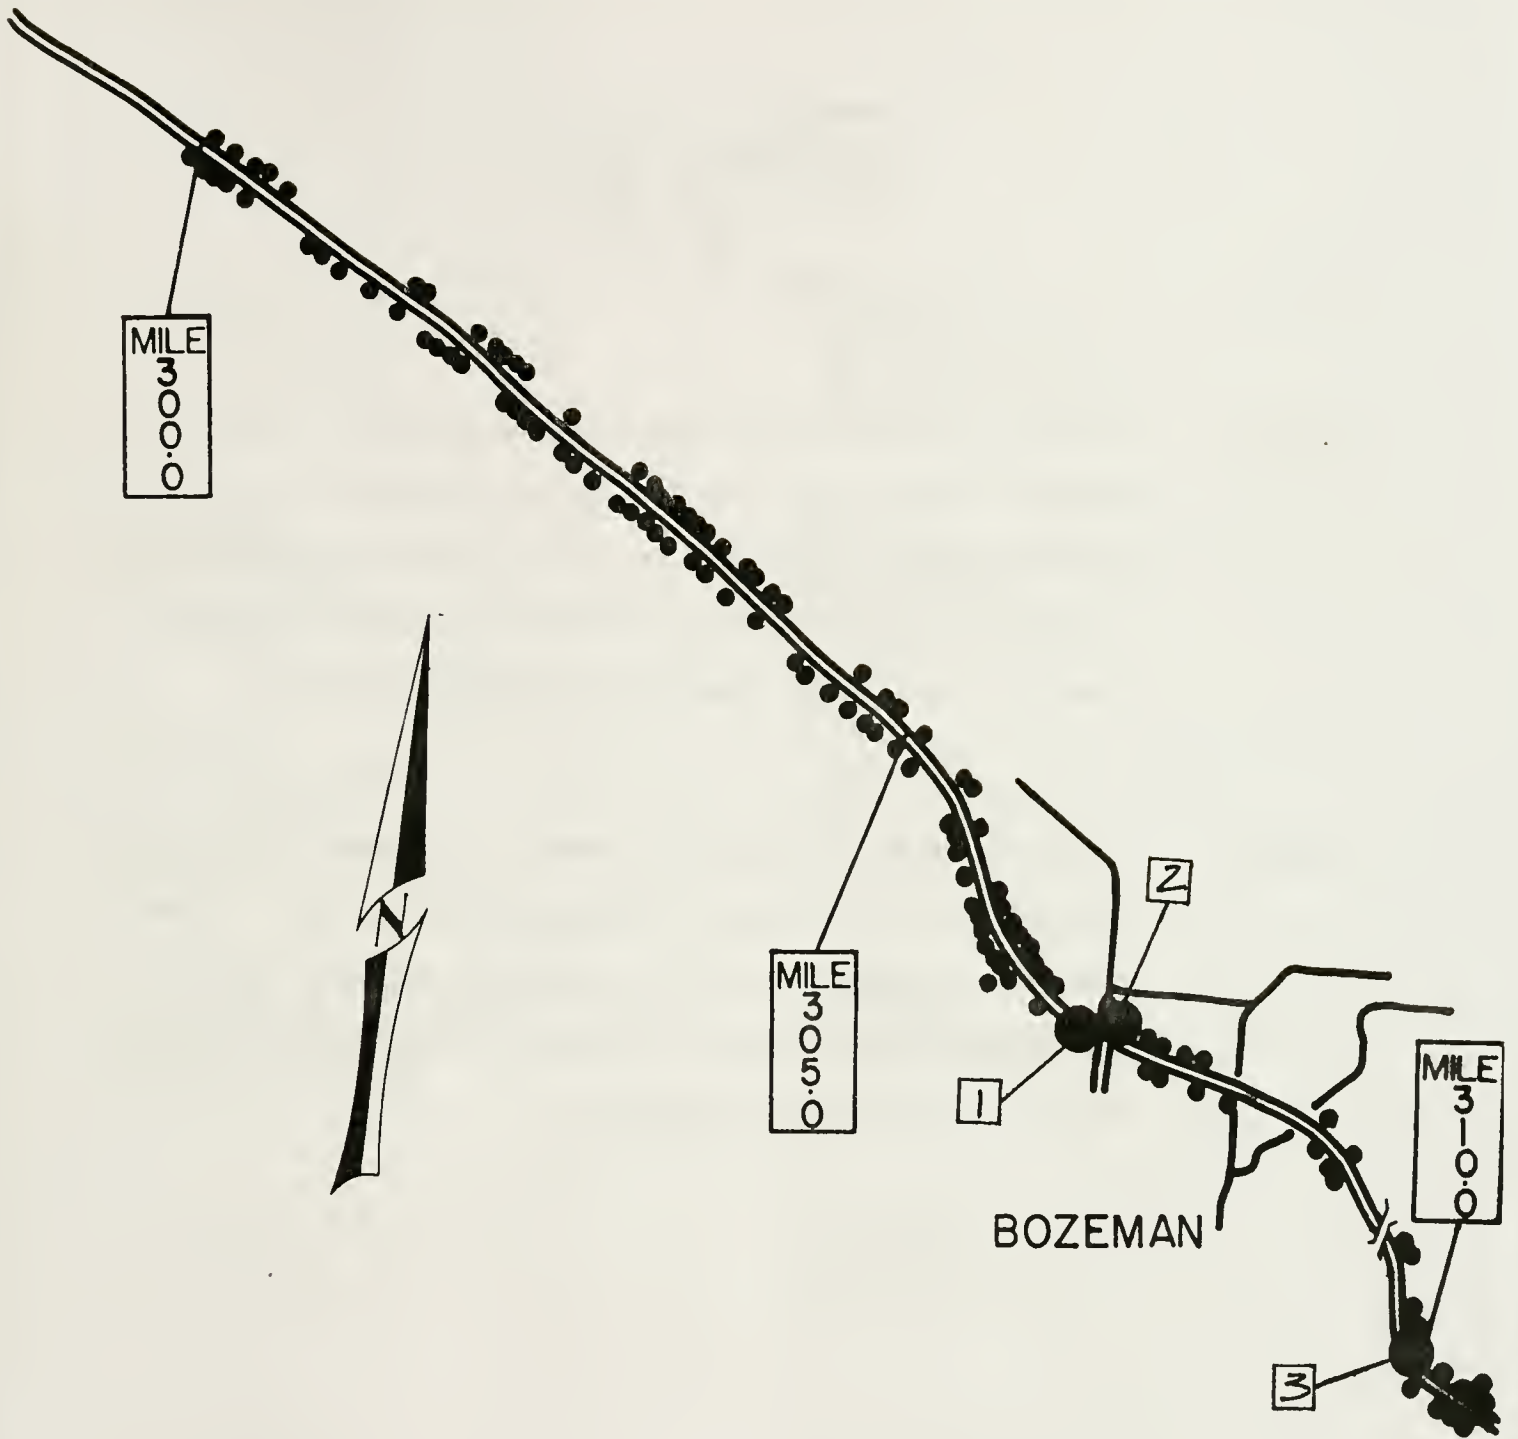
I - 90

General: The 4-lane facility, built in the late 60's - mid early 70's has a plant mix surface treatment with a V-ditch median on the majority of the section. Concrete driving lanes with asphalt shoulders are present at the beginning of the study section.

Comment: Accident occurrence is spread throughout the study area with clusters of accidents occurring at the West Bozeman Interchange and East of Bozeman on a curve section.

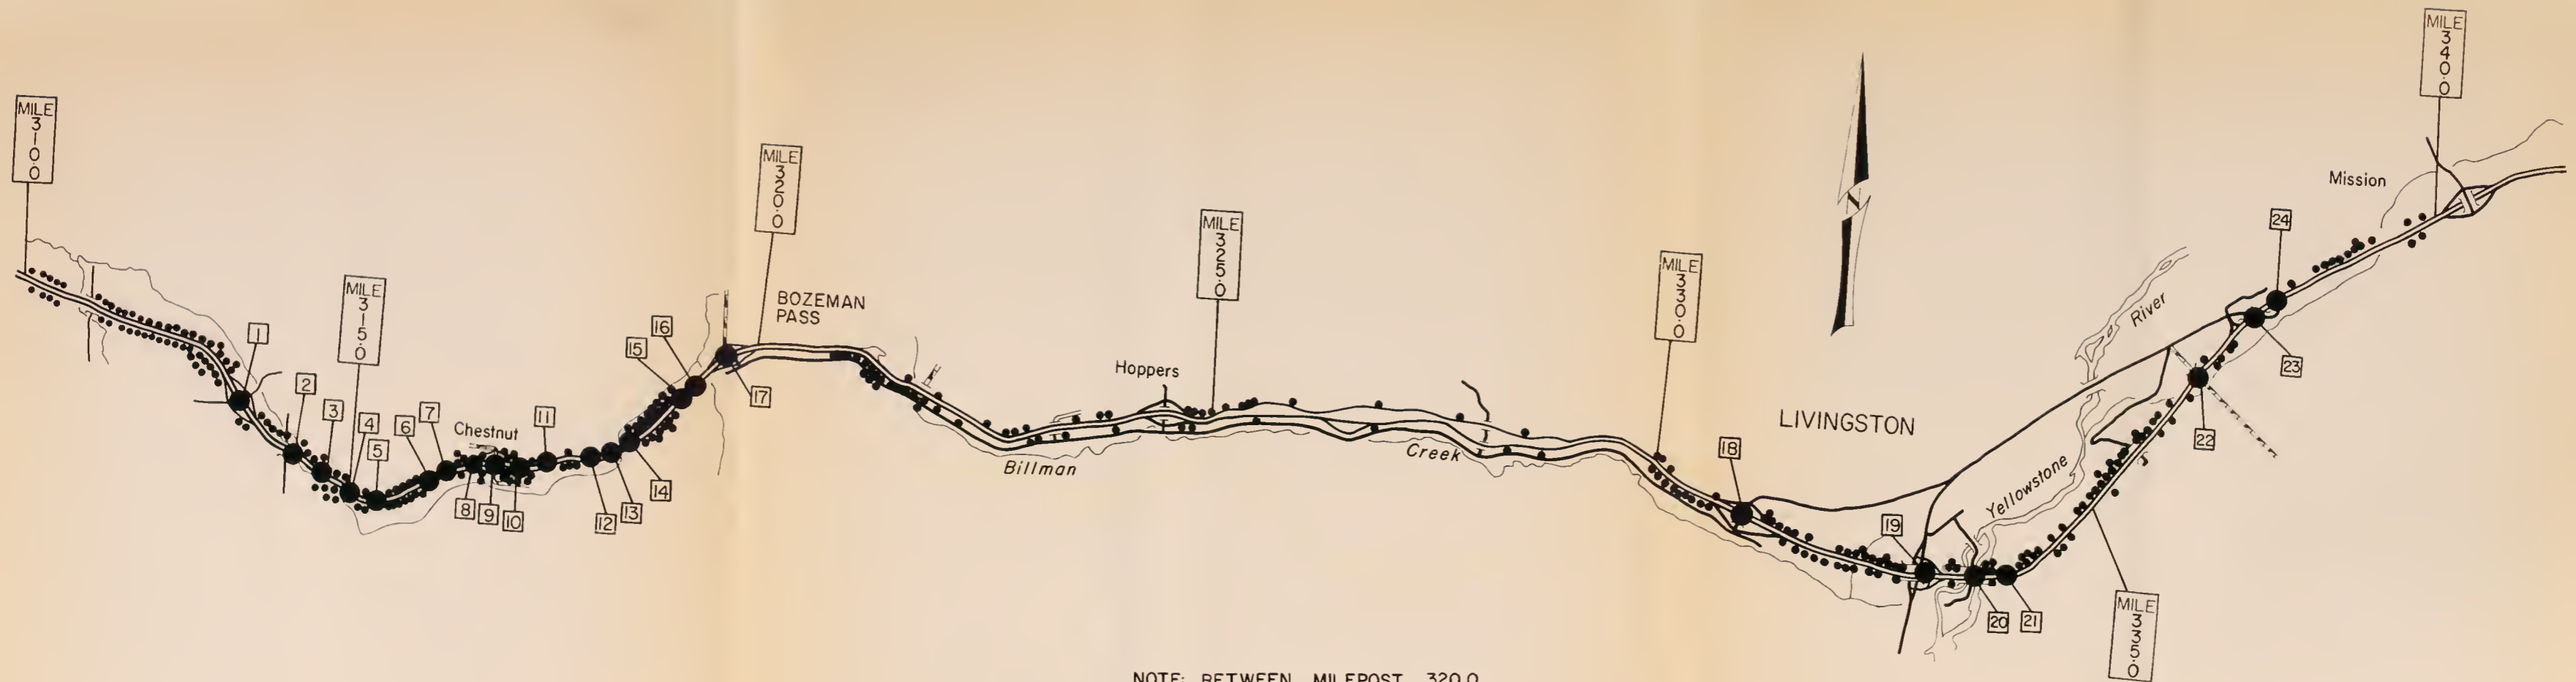
I 90

General: This area includes three study areas contiguously and begins on the East urban limits of Bozeman traverses Bozeman Pass and ends near the Mission Interchange East of Livingston. The area at particular locations experience very high wind velocity causing limited visibility and snowdrifting during winter months.

Comment: A high incidence of accident occurrence has happened with numerous clusters on the west slope of Bozeman Pass to Bozeman. Several clusters of accident also exists in the Livingston area. A Wyoming type snowfence was installed, utilizing safety funds, at various locations near Livingstone.

NOTE: BETWEEN MILEPOST 320.0 AND MILEPOST 330.0 IT IS NEW CONSTRUCTION. ONLY 2 YEARS DATA.

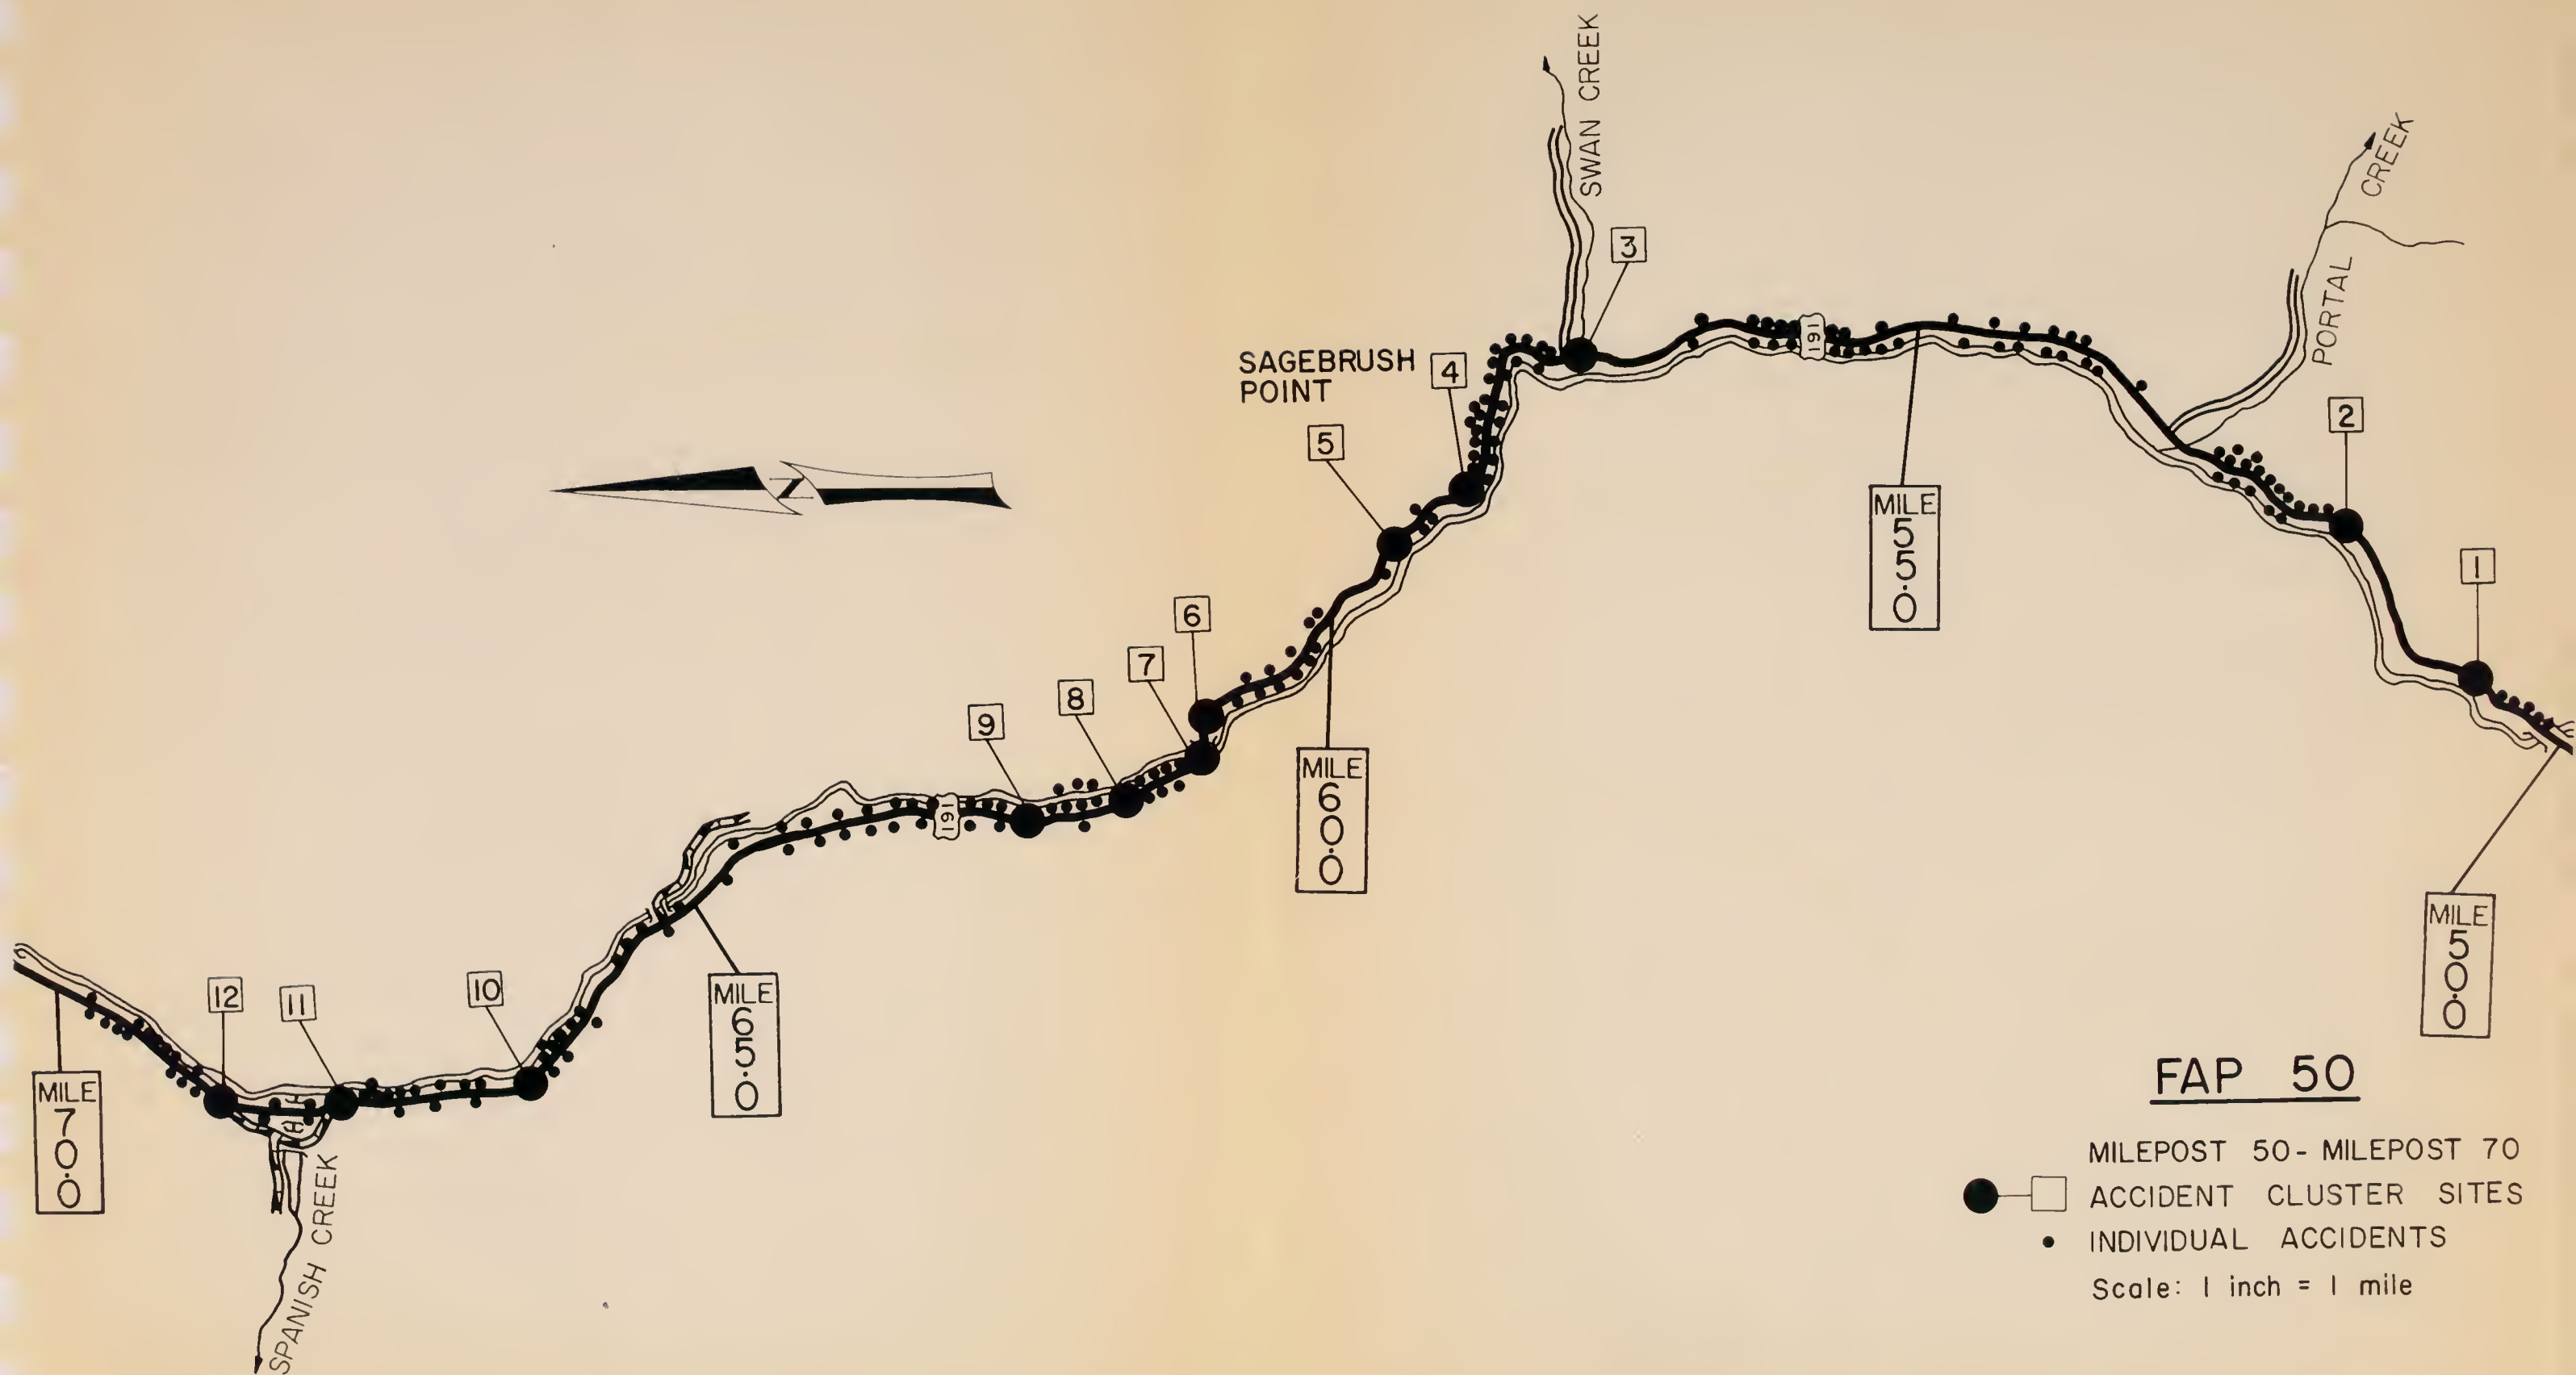
- □ MILEPOST 50 - MILEPOST 70 ACCIDENT CLUSTER SITES
 - INDIVIDUAL ACCIDENTS
- Scale: 1 inch = 1 mile

General: This Federal Aid Primary System Roadway parallels the Gallatin River between Yellowstone Park and Bozeman. This scenic highway experiences high volume tourist traffic entering Yellowstone National Park. The roadway, built in the 50's and 60's traverses heavily timbered mountainous terrain.

Comment: Accident experience is spread throughout the study area with numerous clusters of accidents generally located on curve sections. A safety project to install safety corrections such as guardrail roadway widening and an impact attenuator was installed in 1978 between Milepost 56 - 63. The safety corrections have not impeded snow removal. Accident experience shows a definite reduction after installation of the safety corrections. Special side of the road delineation at Milepost 50+ - 51+ installed on an experimental basis has shown a definite reduction in accidents.

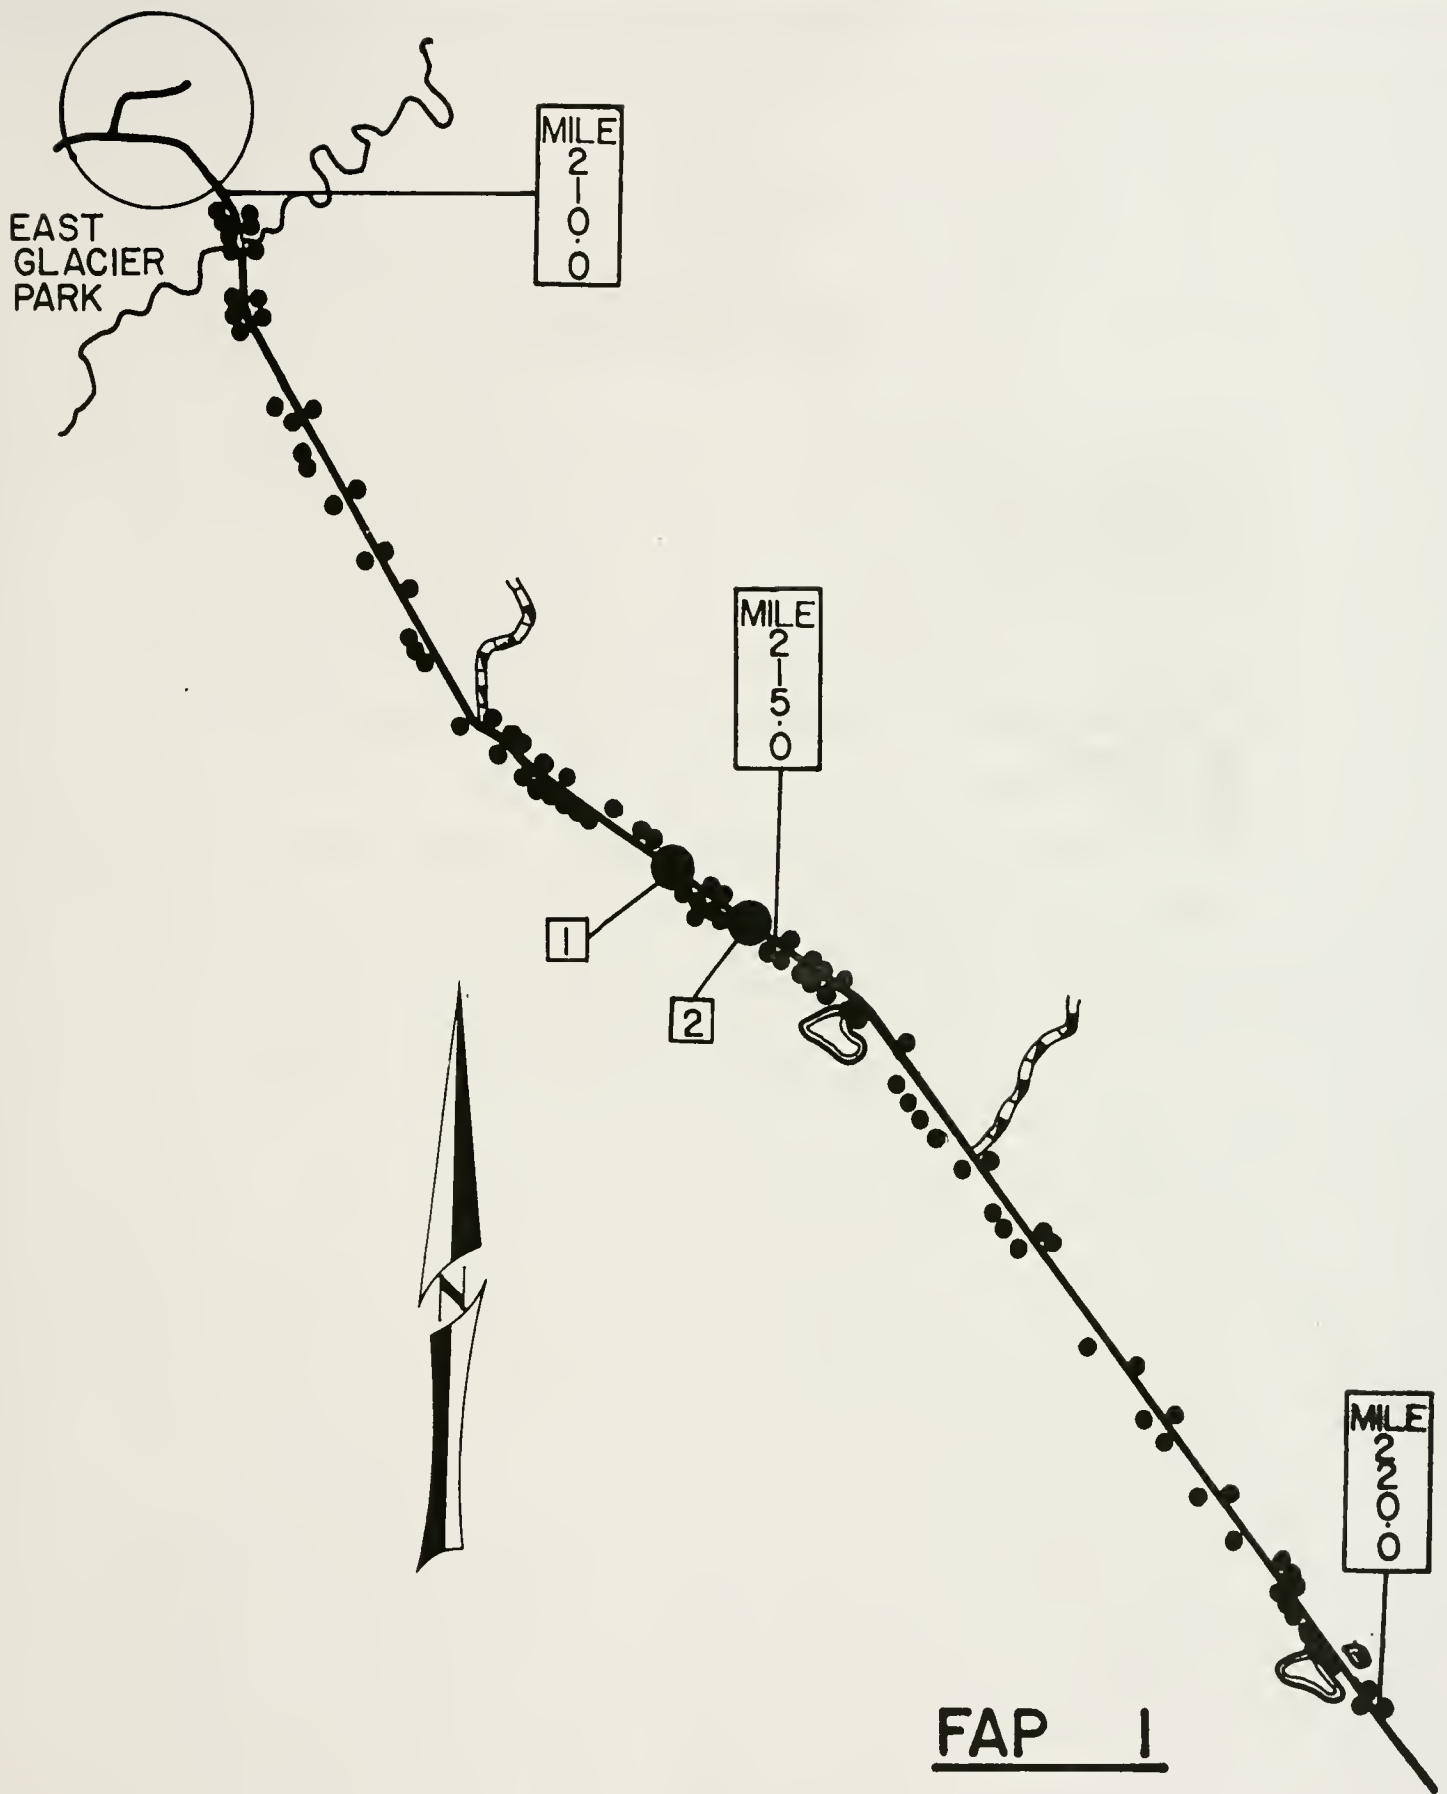
- MILEPOST 210 - MILEPOST 220
- □ ACCIDENT CLUSTER SITES
- INDIVIDUAL ACCIDENTS
- Scale: 1 inch = 1 mile

Comment: Accident history is spread out through the study area. A reduction in accident occurrence is noted on the newer constructed section. A clustering of accidents has occurred on or near the Two Medicine Bridge east of East Glacier.

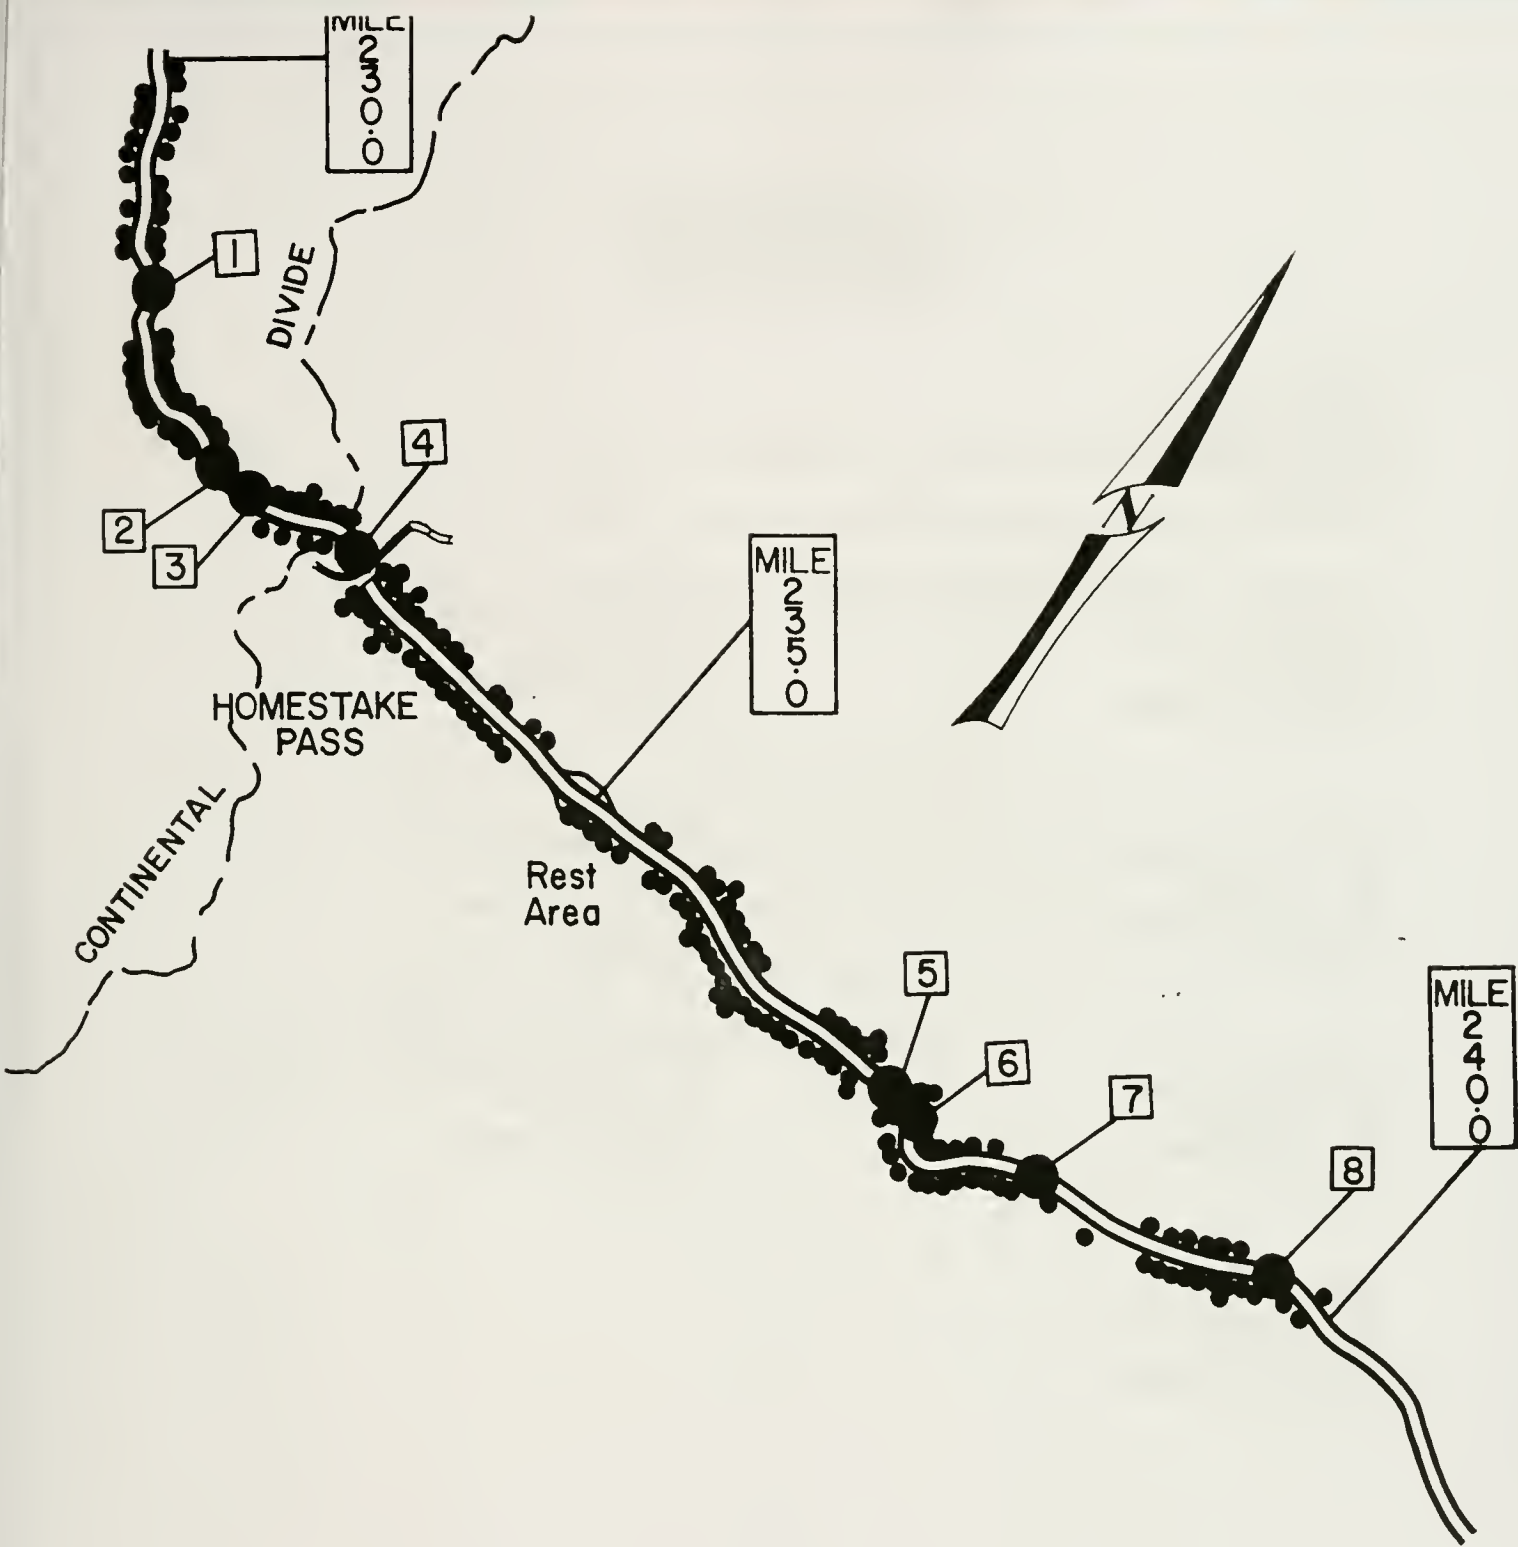
- MILEPOST 230 - MILEPOST 240
- ACCIDENT CLUSTER SITES
- INDIVIDUAL ACCIDENTS
- Scale: 1 inch = 1 mile

General: This study section is a four-lane facility built in 1966 and has a plant mix surface treatment and crosses the Continental Divide at Homestake Pass. One interchange is affected, located on top of the pass.

Comment: Accident history is spread throughout the section. Several clusters of accidents are present particularly on horizontal curve sections and at the area of the interchange. Safety improvements, particularly directed for large trucks, has been placed on the east slope of Homestake Pass.

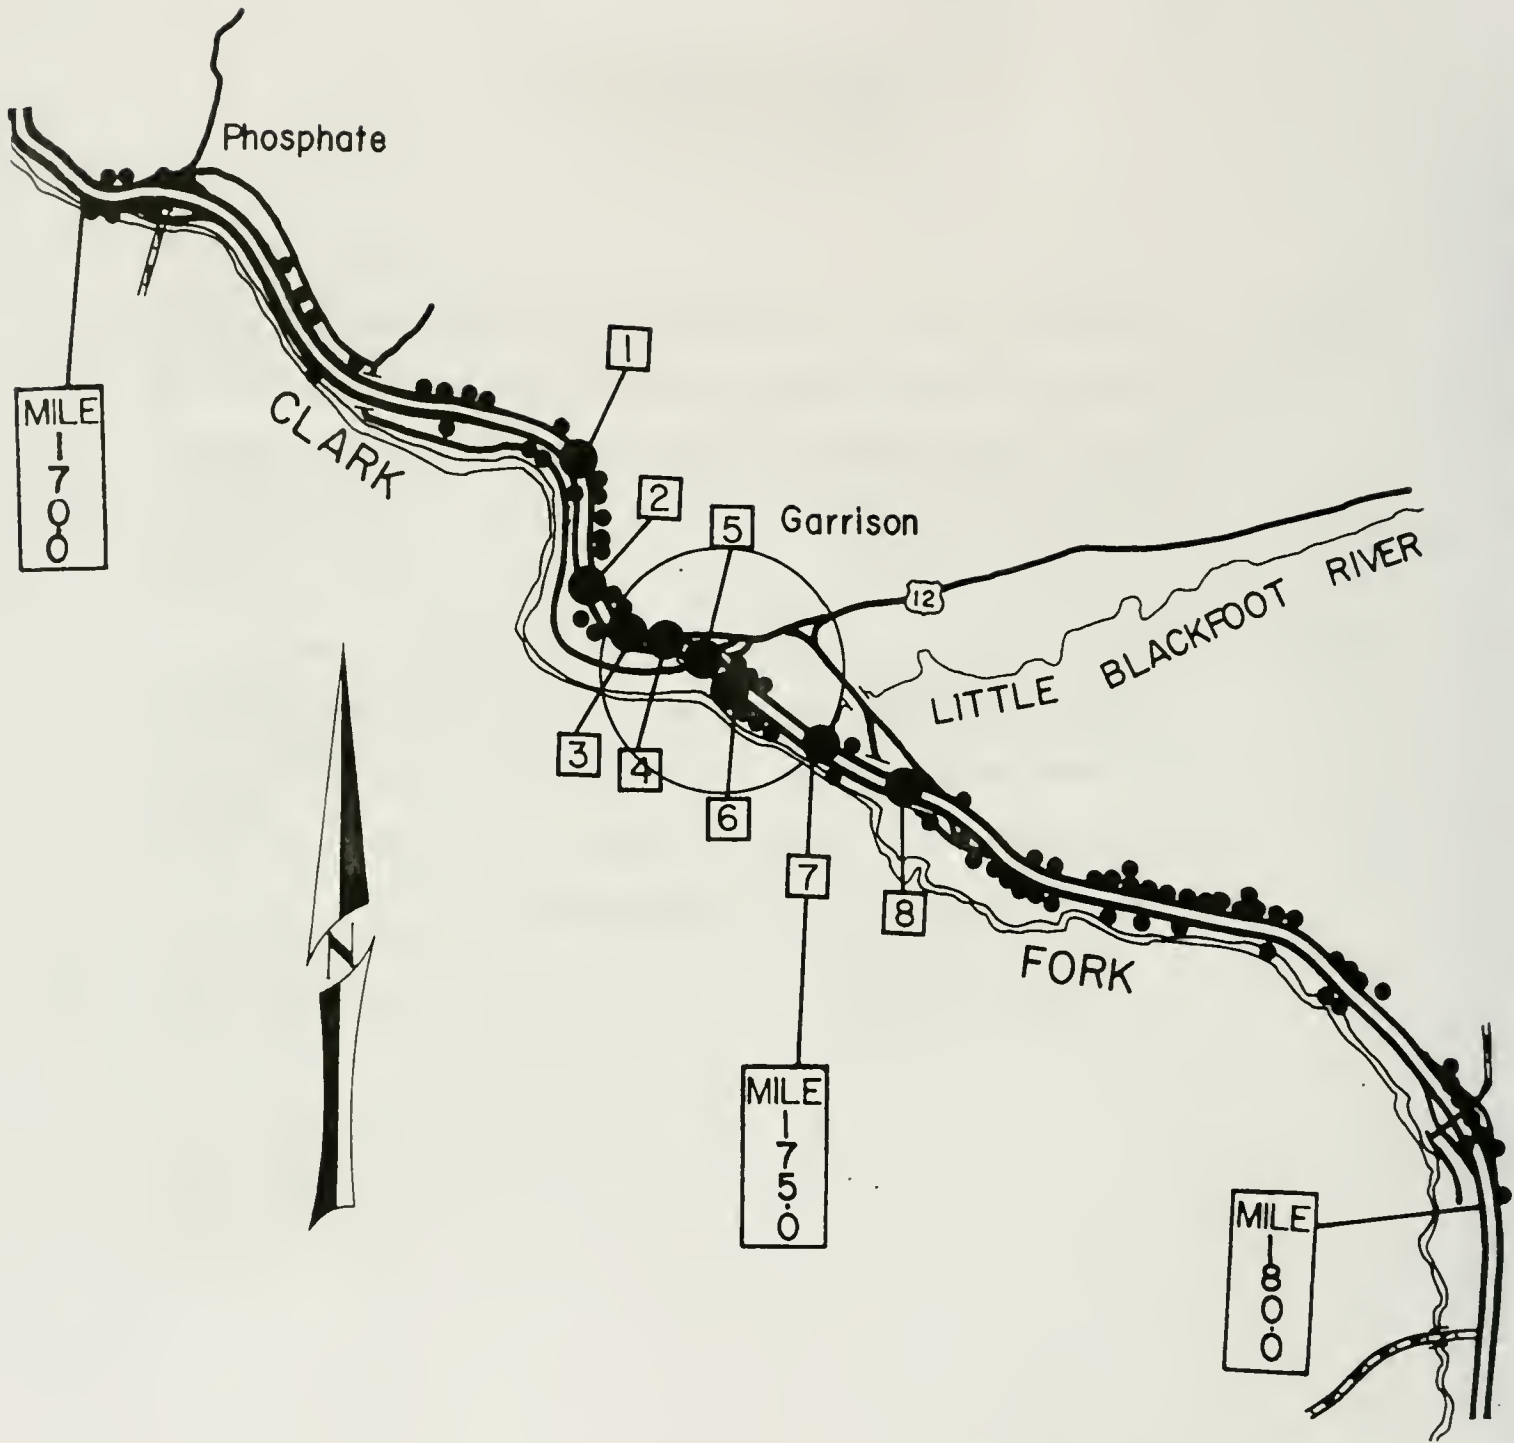
- MILEPOST 170 - MILEPOST 180
- □ ACCIDENT CLUSTER SITES
 - INDIVIDUAL ACCIDENTS
- Scale: 1 inch = 1 mile

General: The majority of this study area was under construction at the time of the field review. The roadway section from Milepost 176+ was constructed in 1976.

Comment: Accident information shown on the accompanying map should be disregarded except for information shown from Milepost 176+ to 180. Accidents shown between 170 - 176+ reflect occurrence on the old traveled way.

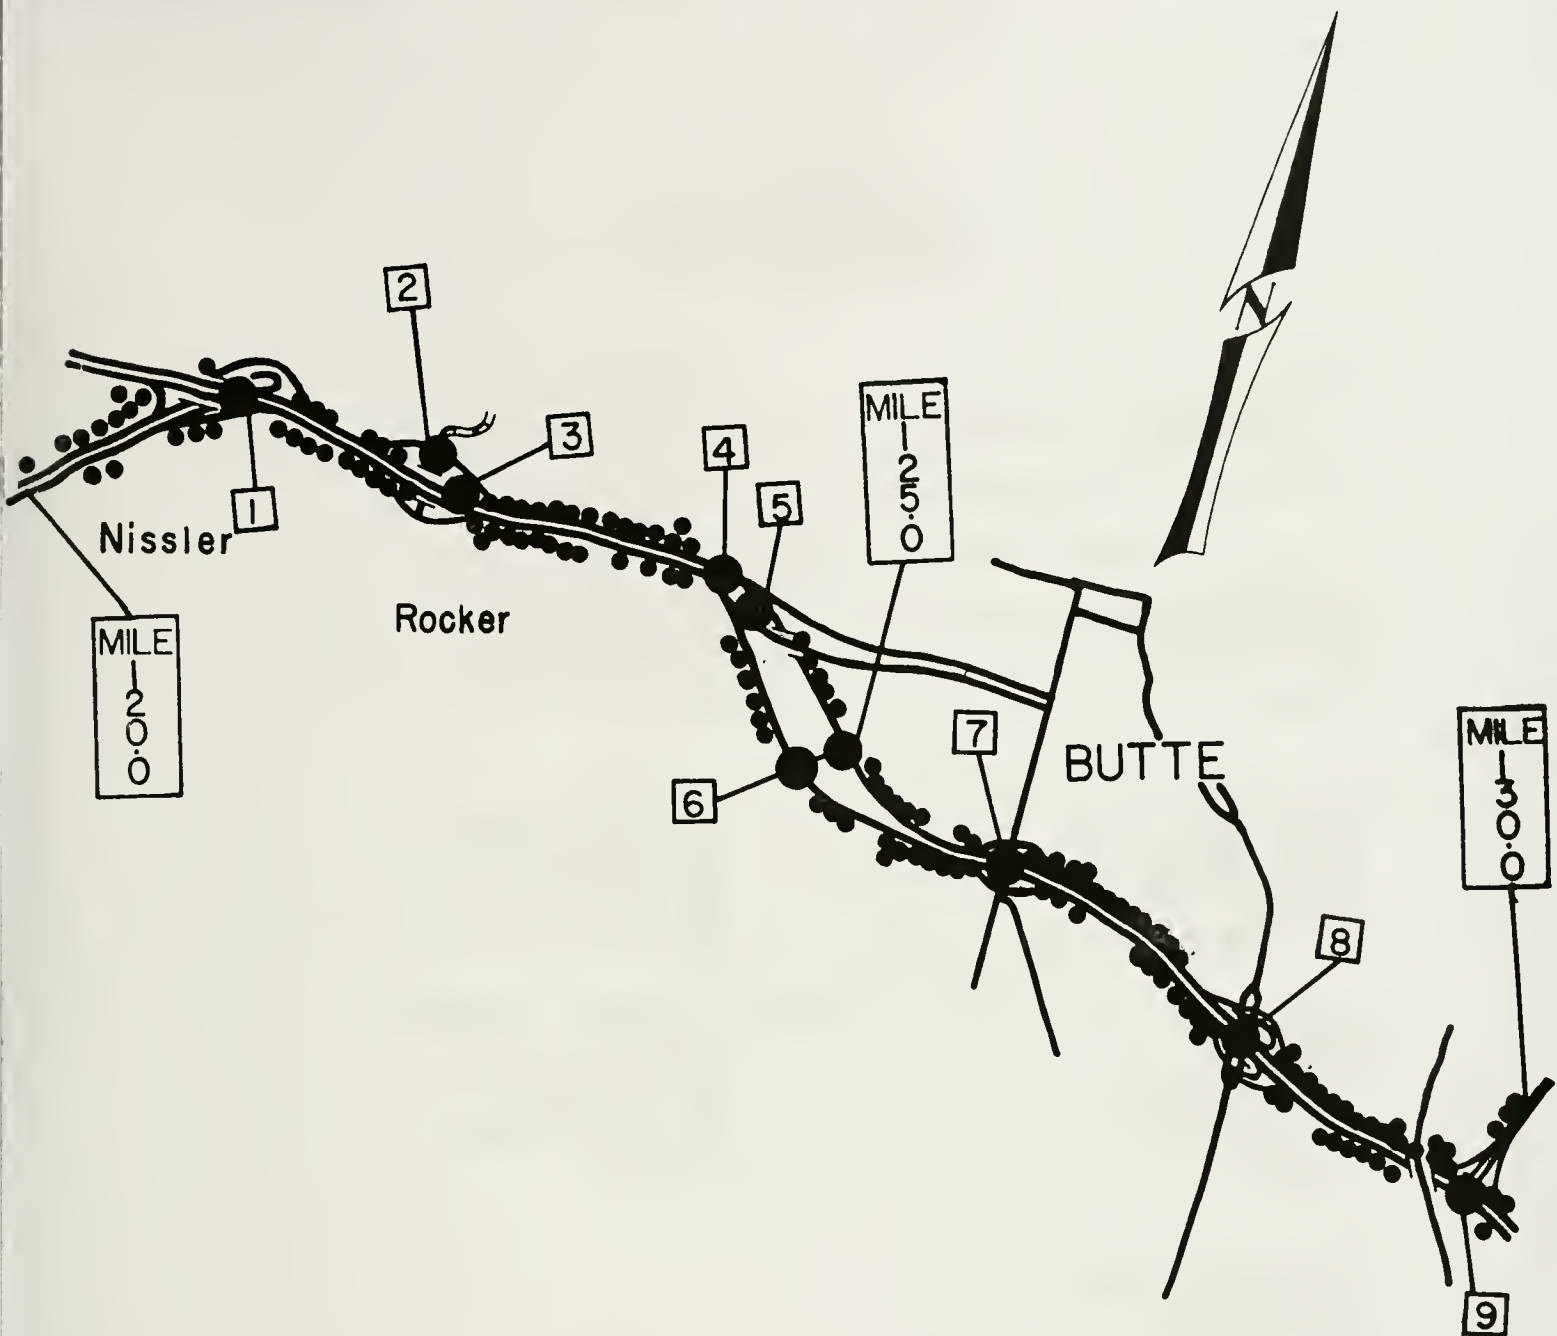
- — □ MILEPOST 120 - MILEPOST 130
 - ACCIDENT CLUSTER SITES
 - INDIVIDUAL ACCIDENTS
- Scale: 1 inch = 1 mile

- General: The study section traverses the city of Butte and includes numerous interchnages. High traffic volumes and turning maneuvers attribute in part to the high incidence of accidents. The majority of the roadway in this section was constructed in the 1960's.
- Comment: Clusters of accidents have occured at all the interchange areas in this section. Cluster also occured on the west side of Butte where a left hand off ramp is present. Frequent accident occurance is spread throughout the section.
